Sample Home Inspection Report

Feel Safe Home Inspection LLC

Needs Repair Summary

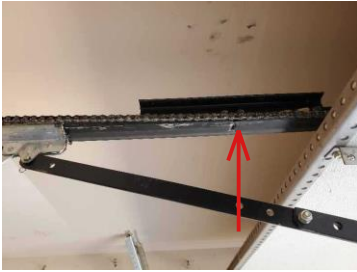
1. Attached Garage Door Operation: Chain drive needs adjustment should not be that much slack in it

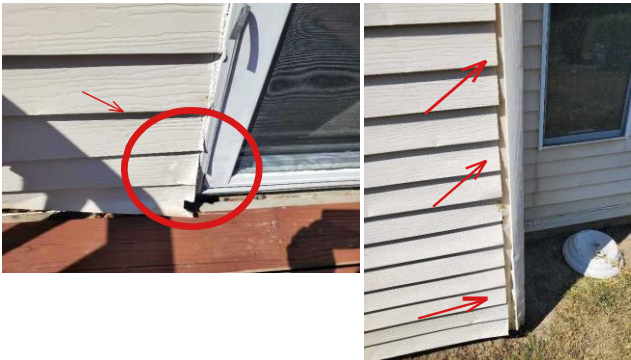
2. Entire townhouse Exterior Surface Type: Aluminum siding - Siding next to patio door is pulled away water can get behind. Corner of fireplace siding needs repair it is pulled away and can cause water to enter house

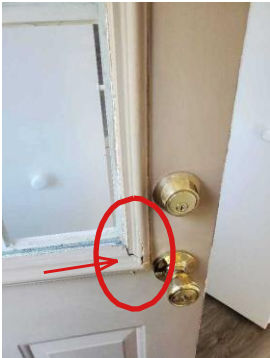
3. Entry Doors: Trim around window broken needs repair

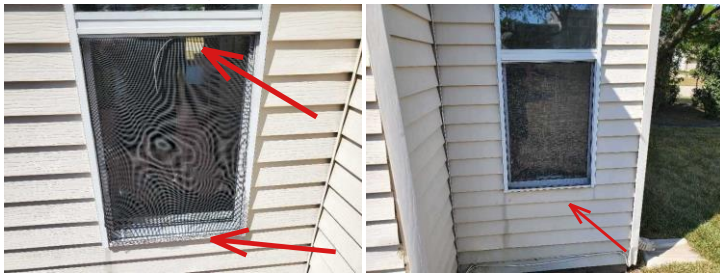
4. Window Screens: Screen is torn and will need repair

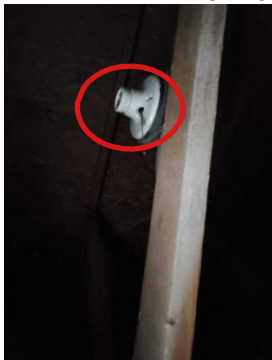
5. Main Attic Wiring/Lighting: No bulb in fixture

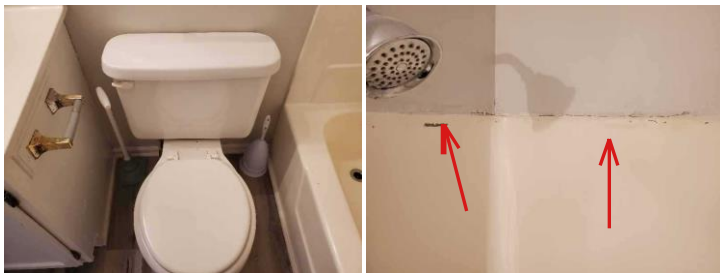
6. 2nd floor main Bathroom Toilets: Water continues to run after flushing very long time to fill fully

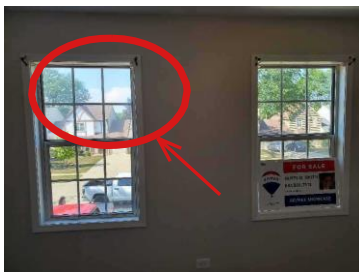
7. Master Bedroom Windows: Aluminum double hung - Window has fogging between the layers of glass

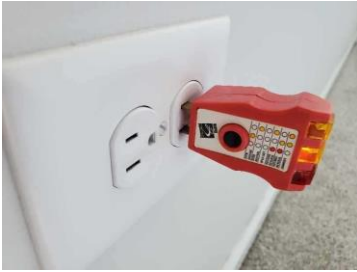
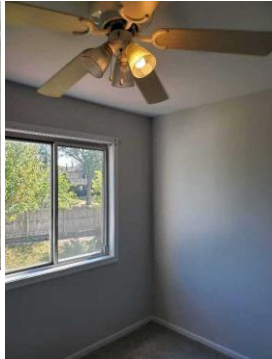
8. Behind bathroom Bedroom Electrical: 110 VAC outlets and lighting circuits - **Open or missing ground most outlets light bulb burned out**

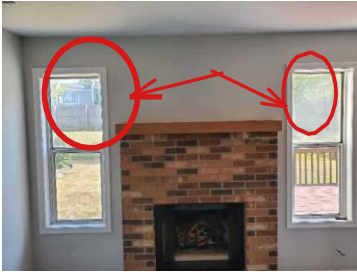
9. Living Room Living Space Windows: Aluminum double hung - **Window has fogging between the layers of glass**

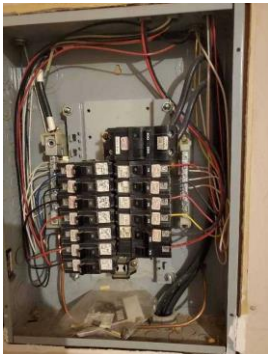
10. Garage Electric Panel Manufacturer: Federal Pacific - **Federal Pacific panel breakers have a history of not tripping when circuit overloading exists**

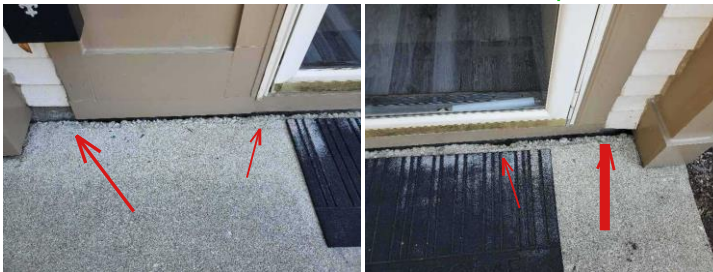
4. Acceptable Porch: Concrete - Watch to make sure the porch doesn't further separate from house

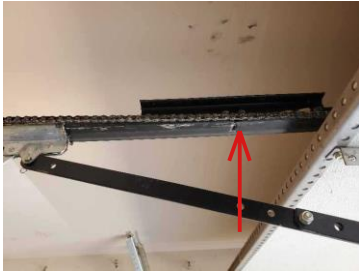
1. Type of Structure: Attached Car Spaces: 1
2. Acceptable Garage Doors: Metal
3. Needs Repair Door Operation: Chain drive needs adjustment should not be that much slack in it

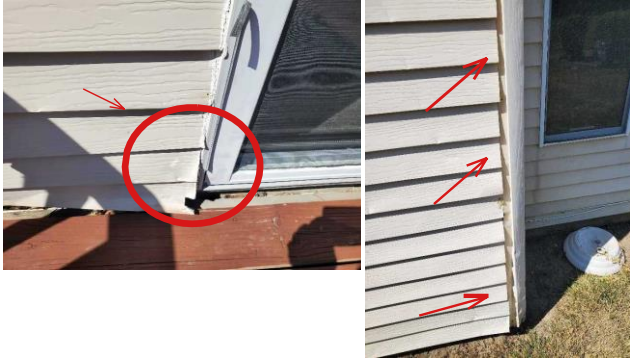
1. Needs Repair Type: Aluminum siding - Siding next to patio door is pulled away water can get behind. Corner of fireplace siding needs repair it is pulled away and can cause water to enter house

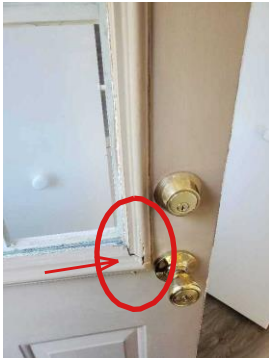
2. Acceptable Trim: Painted wood and aluminum
3. Acceptable Fascia: Painted wood
4. Acceptable Soffits: Painted wood
5. Acceptable Door Bell: Hard wired
6. Needs Repair Entry Doors: Trim around window broken needs repair

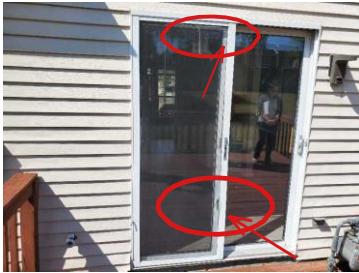
7. Acceptable Patio Door: Metal sliding - Screen door does not slide and Screen is torn

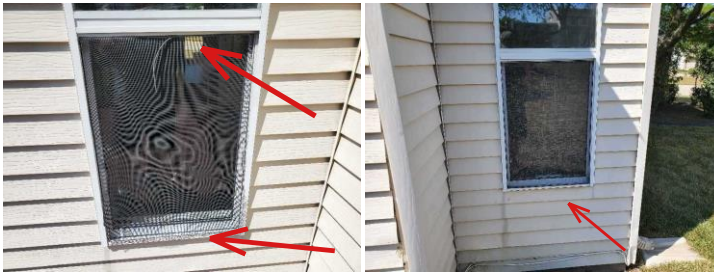
9. Needs Repair Window Screens: Screen is torn and will need repair

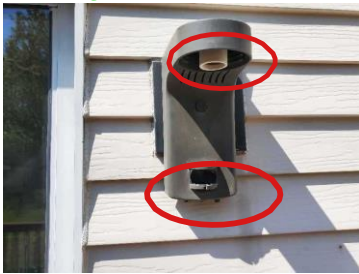
Exterior Lighting: Surface mounted lamps front and rear - Backlight has no bulb and sensor is missing

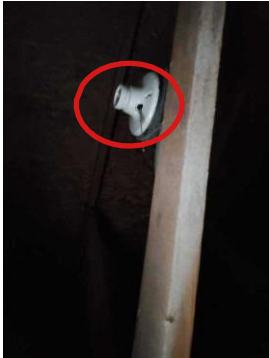
1. Acceptable Roof Framing: 2x4 Truss
2. Acceptable Sheathing: Strand board
3. Acceptable Ventilation: Roof and soffit vents
4. Acceptable Insulation: Batts
5. Acceptable Insulation Depth: 6 to 8 inches
6. Acceptable Vapor Barrier: Paper
7. Needs Repair Wiring/ Lighting: No bulb in fixture

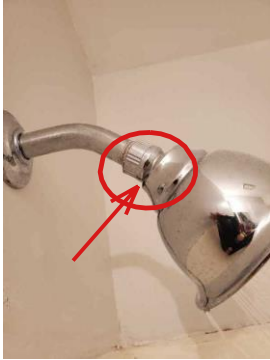
- 5. Acceptable Floor: Faux wood
- 6. Not Present Windows:
- 7. Acceptable Counter/ Cabinet: Composite and wood
- 8. Acceptable Sink/Basin: One piece sink/counter tops
- 9. Acceptable Faucets/Traps:
- 10. Acceptable Tub/Surround: Fiberglass tub and fiberglass surround - **Obvious water damage due to water penetration also leaking shower head**

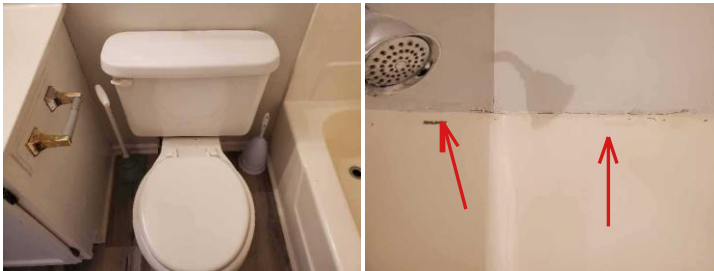
- 11. Needs Repair Toilets: **Water continues to run after flushing very long time to fill fully**

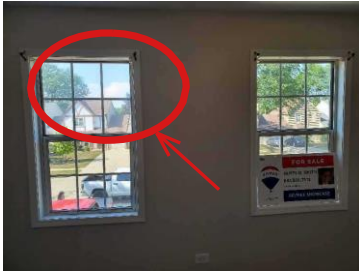
1. Acceptable Closet: Walk In
2. Acceptable Ceiling: Paint
3. Acceptable Walls: Paint
4. Acceptable Floor: Carpet
5. Needs Repair Windows: Aluminum double hung - Window has fogging between the layers of glass

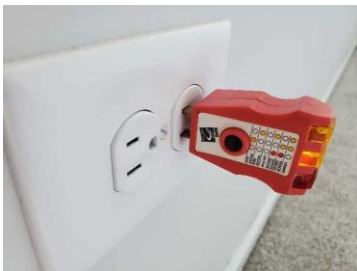
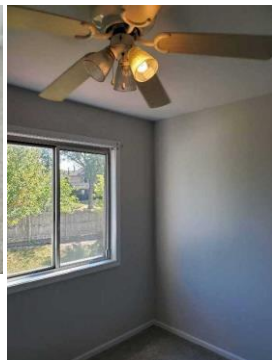
10. Acceptable Closet: Single
11. Acceptable Ceiling: Paint
12. Acceptable Walls: Paint
13. Acceptable Floor: Carpet
14. Acceptable Windows: Aluminum slider
15. Needs Repair Electrical: 110 VAC outlets and lighting circuits - Open or missing ground most outlets light bulb burned out

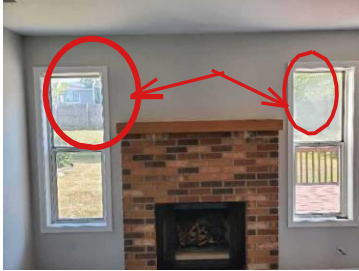
- 8. Acceptable Ceiling: Paint
- 9. Acceptable Walls: Paint
- 10. Acceptable Floor: Carpet
- 11. Needs Repair Windows: Aluminum double hung - Window has fogging between the layers of glass

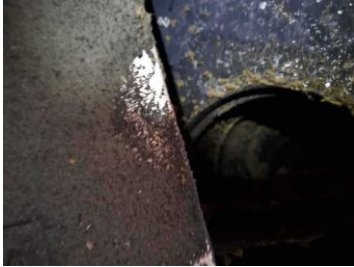
1. Acceptable Freestanding Stove: Wood burning - **Recommend cleaning and inspection prior to use**
2. Acceptable Fireplace Construction: Prefab
3. Type: Gas log
4. Acceptable Fireplace Insert: Standard
5. Acceptable Smoke Chamber: Metal
6. Acceptable Flue: Metal

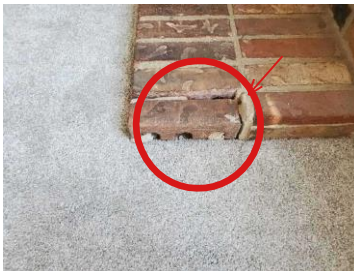
7. Acceptable Damper: Metal
8. Acceptable Hearth: Flush mounted - **Loose brick**

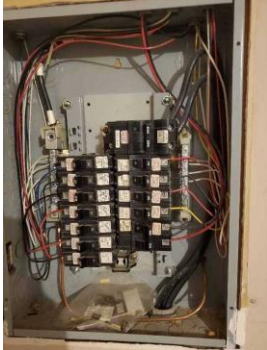
7. Needs Repair Manufacturer: Federal Pacific - Federal Pacific panel breakers have a history of not tripping when circuit overloading exists
